| For: NONDESTRUCTIVE RESIDENTIAL |) | Attorney Docket No.: |
| INSPECTION METHOD AND |) | 1038406-000004 |
| APPARATUS |) | |

AMENDED APPEAL BRIEF

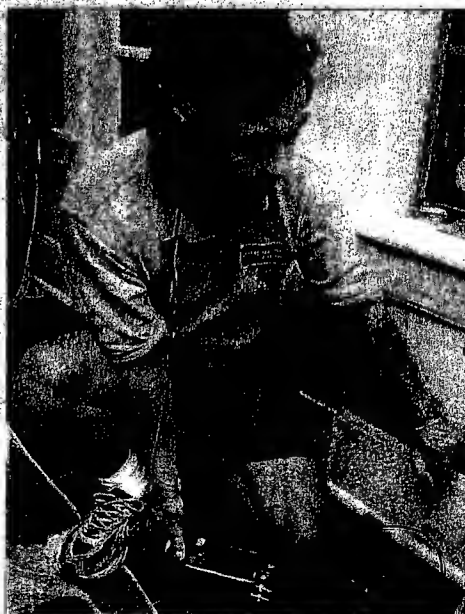
Peng Lee of HomeSafe Inspection uses a special sensor to listen for termites at the Judy Johnson home.

By pushing a needle-like sensor through the wall or inserting it between the floor and the wall, inspectors can detect termite noises that the human ear cannot hear. Questionable sounds are fed into a PocketPC, and software unique to HomeSafe can recognize and identify them.

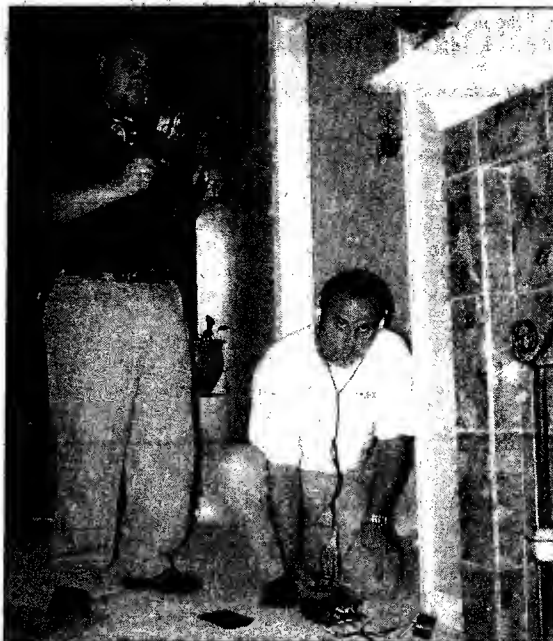
Ryan Rubenstein, left, demonstrates how to use an infrared camera during a home inspection while Bob Rushing checks for termites with a high-tech acoustic sensor. Rubenstein and Rushing recently opened a HomeSafe Inspection franchise in Ocean Springs. The business partners offer the most technologically advanced home inspections available.

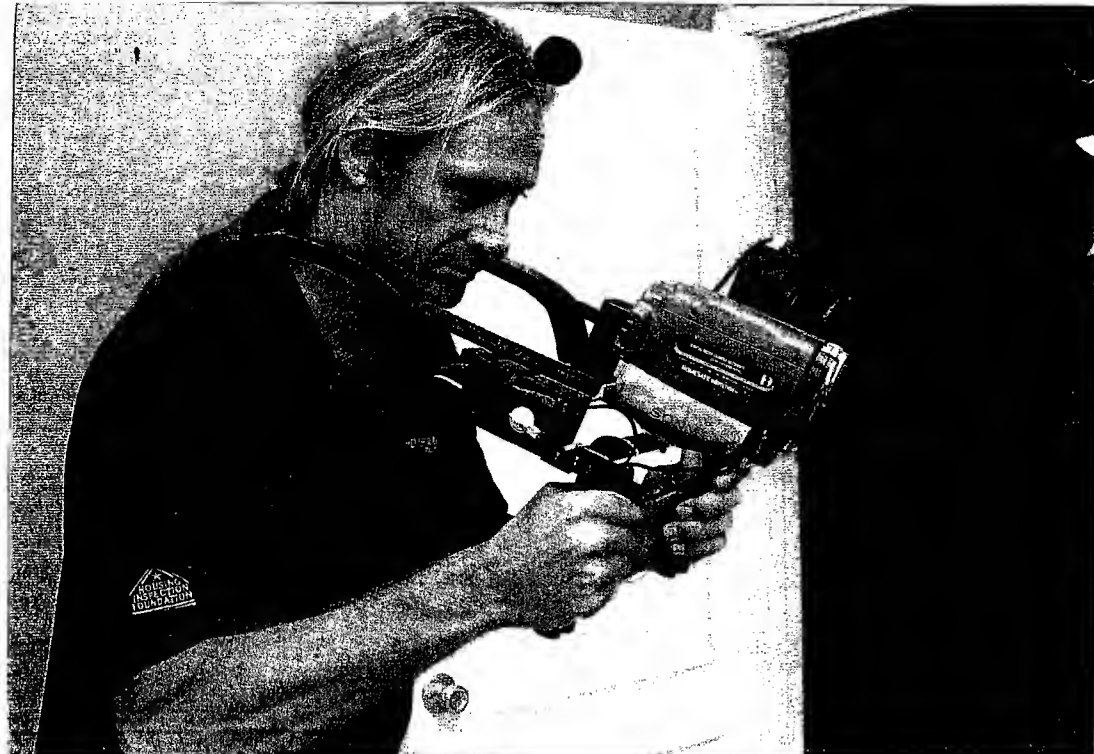
Kenny Phillips, a home inspector with HomeSafe Inspection, examines a room with an infrared camera. The camera allows the inspector to see inside the walls and spot damages not visible to the naked eye.

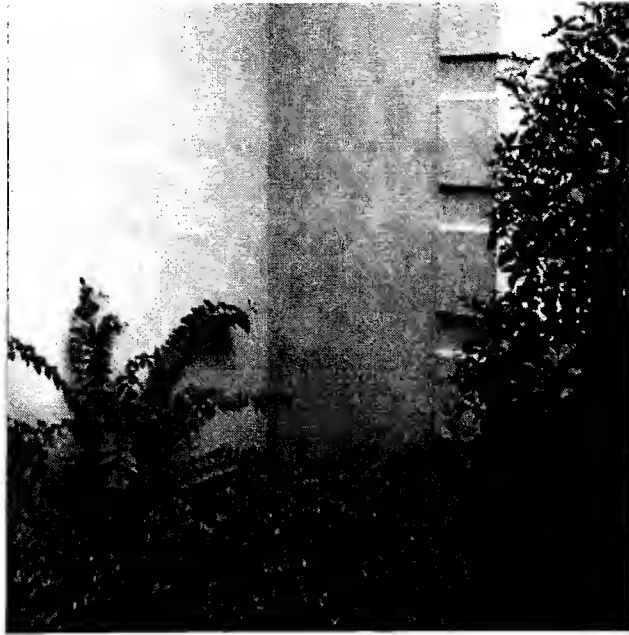
[0021] FIG. 4A is a visual photograph of an EIFS wall.

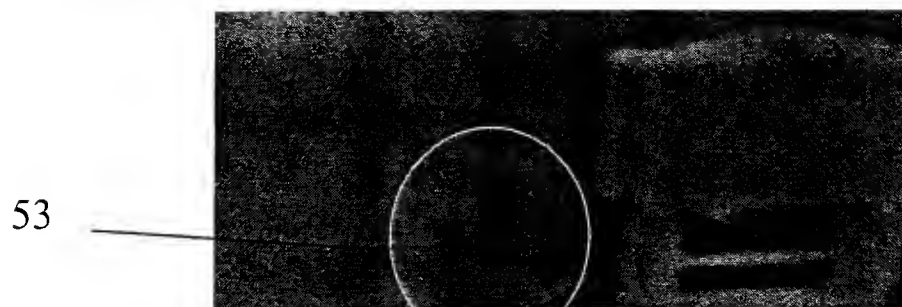
[0056] FIG. 25 is a temperature profile of a residential interior component.

[0120] (7) *Structural Misalignment or Damage* – In the case of less than perfect construction techniques, the trained observer can spot missing, mis-aligned or damaged internal structural members such as studs, headers, trimmers and the like. In some cases, those damaged or missing members may contribute to otherwise unaccounted for interior damage that would normally point to foundation troubles, but which are, in fact, framing problems. FIGS. 24 and 25 are temperature profiles of interior components of a residential building. In Figure 24, the thermal anomaly 31 is indicative of a structural misalignment. In Figure 25, the
